Manhole Inspection Summary

Manhole # S3100_004MH

Insp Date: **4/25/07 12:05 PM**

Location Address: **454 FAWCET ST**

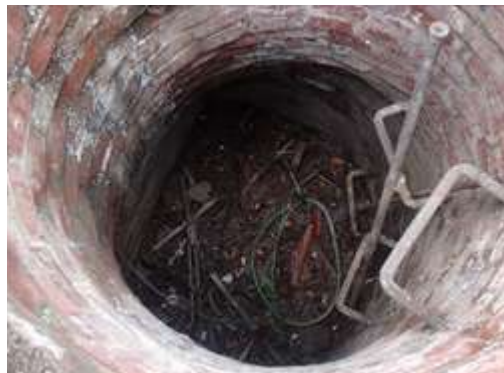
Top View

Channel debris.

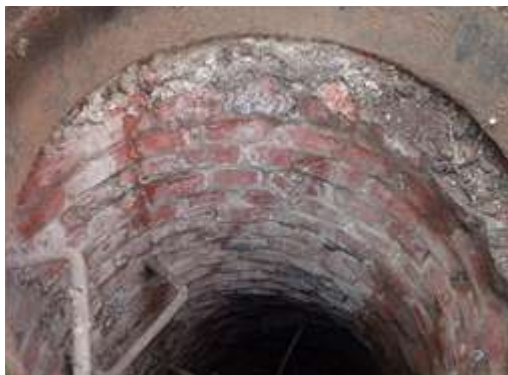
Defect

Frame leaks. Frame offset. Adjustment and Corbel deterioration and infiltration. Barrel infiltration.

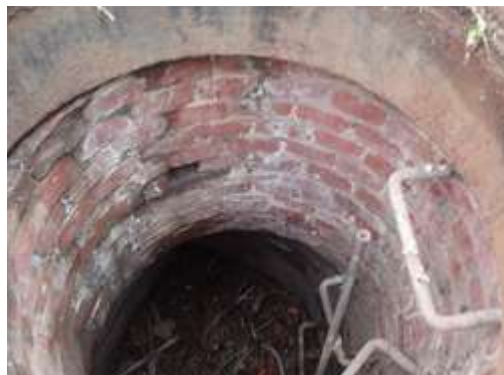
Defect

Frame leaks. Adjustment and Corbel deterioration and infiltration. Barrel infiltration.

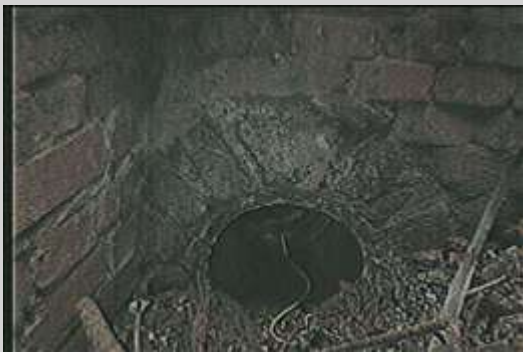
8 in. Circular Gravity Sewer
Pipe Out @ 12 O'Clock

Barrel deterioration and infiltration.
